# 1965 to 1973 Ford Suspension Restoration and Identification Guide

MARCUS ANGHEL

The first generation Mustangs built from 1965 to 1973 all basically share the same front and rear suspension design. In many ways the components are more similar during these years then they are different. But, from year to year, and with certain models and engine options, there was design changes and unique pieces.

The purpose of this guide is to serve as a single reference and resource when restoring, judging, or identifying parts. When going thru the process of a restoration its always best to use original parts as much as they are available to bring that car back to its Day 1 assembly line heritage and also because original parts fit exactly as designed and intended.

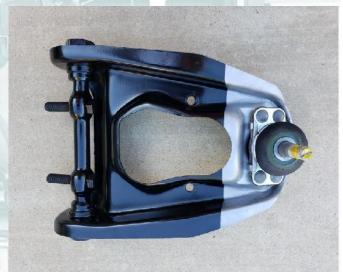
#### 1965 and 1966: C4DZ-3082-B

The control arms used during these years, at first glance, look identical to control arms from later years with one key difference. The overall size is smaller. Shown above this measurement is slightly smaller and an easy way to identify what is correct. Other ways to identify these control arms are listed here as well. Note, the paint that was applied to these control arms from the factory generally has them dipped in black paint 1/2 to 3/4 of the way leaving the ball joint area bare metal. Its not uncommon to see the drips and runs from that process of having them dipped.

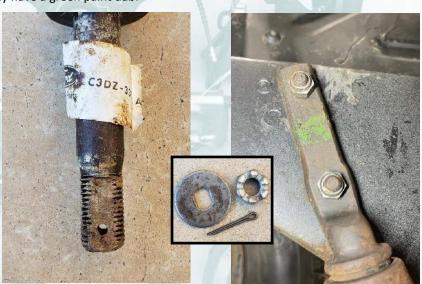
## 1965 and 1966 Idler Arm Mounting Bracket

For these two years Ford designed the idler arm as two sub-assembles, with the idler arm and the idler mounting bracket being two distinct parts with two distinct different part numbers. The idler mounting bracket was serviced under the part number of C3DZ-3351-A (shown below). This piece would bolt to the body of the car and be attached to the idler arm with a washer, cotter pin and cotter nut and typically have a green paint dab.

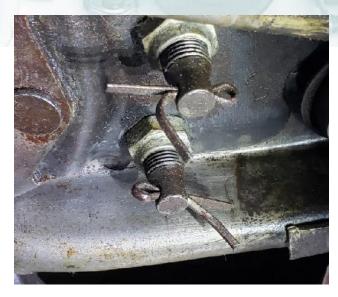
Pictures here show typical installation of the lower control arms on two unrestored low mileage cars. The strut rods on a 1969 Boss 429 (left) and a 1968 Mustang (right side photo). Notice the cotter pins and how they are installed and the hardware.

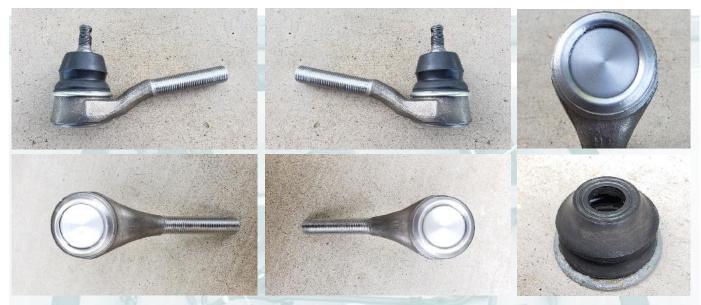
## Six cylinder Mustang, with manual steering

The simplest and most basic of all tie rod combinations. The inner and outer tie rods are essentially the same with the only difference being the threaded ends. One tie rod has left hand threads, and the other has right hand threads.

Inner tie rods are a C3DZ-3A130-L and the outer tie rods are a C3DZ-3A130-K. The ball stud uses a 3/8-24 castle nut and the tie rod boot has the metal ring as shown visible. The end cap detail shown above with no visible stampings on the end cap. The original tie rod boot (C3DZ-3332-A) does not have any engineering numbers, but do have a mold number, mold cavity number and a source identification number.

Tie rod sleeves (C5ZZ-3310-A) are a 1/2-20 thread with left hand thread on one side and right hand thread on the other side. The left handed thread side is marked with a small hole that is drilled in the sleeve for identification. Overall length of the sleeve is 5 7/8 inches. The clamps are held in place with bolts that have a fine thread 5/16-24 and with shoulder nuts. Most common head markings as shown being an A or a RSC.

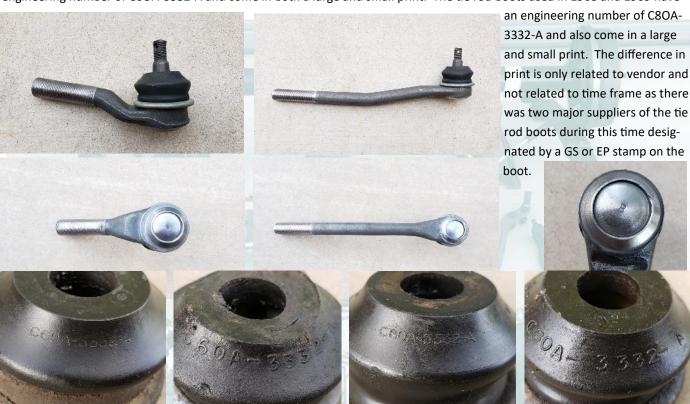
#### Tie Rods 1967—1969

Starting in the 1967 model year, Ford simplified the suspension design and only had an inner and an outer tie rod that were unique and there was no longer differences for 6 and 8 cylinder models and no differences for manual and power steering like the previous years. The cap design on the end of the tie rod changed as well, with the most common instance having a B stamped in the center, although not all examples have that. Some may have no stamp. Inner tie rods are a C7ZZ-3A131-A and the outer tie rods are a C7ZZ-3A130-A. The tie rod ball stud uses a 7/16-20 castle nut. The tie rod boots used in 1967 have an engineering number of C6OA-3332-A and come in both a large and small print. The tie rod boots used in 1968 and 1969 have

The tie rod adjusting sleeve is a C2AA-3310-B with an 11/16-18 thread. The clamps totally change from previous years and are now a B7A-3287-A and look completely different. Bolts have a 5/16-24 thread during 1967 and 1968 and change to a 5/16-18 coarse thread in 1969. There were two suppliers of the bolts; Ajax Bolt and Screw Co (A) and Republic Steel Corporation (RSC). The fine thread bolts have two different versions of locking nuts that are used, but when the switch is done to the coarse thread only one style of locking nut is used.

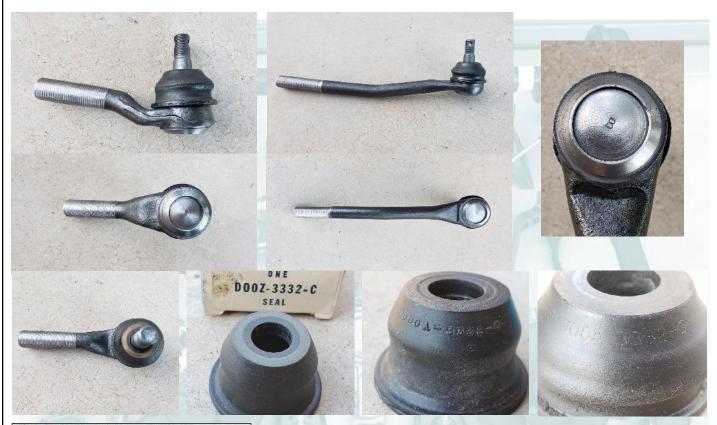
## Tie Rods 1970

In 1970 Ford again changed the design of the tie rod assemblies. The tie rods now have a larger style tie rod ball stud that had a 1/2-20 threaded end. The inner tie rods are a DOZZ-3A131-B and the outer tie rods are a DOZZ-3A130-B. There is now a new version of tie rod boot that no longer has a visible metal ring around the base. The tie rod boot has an engineering number of DOOA-3332-C molded in the boot and come in both a large and small print with the difference being two different vendors supplying the boots.

The tie rod adjusting sleeve is a C2AA-3310-B with an 11/16-18 thread. The clamps are a B7A-3287-A. Bolts have a 5/16-20 coarse thread design. There were two suppliers of the bolts; Ajax Bolt and Screw Co (A) and Republic Steel Corporation (RSC). The bolts are held in place with a locking style nut as shown in the photos with two versions of locking nuts being used from two different sources.

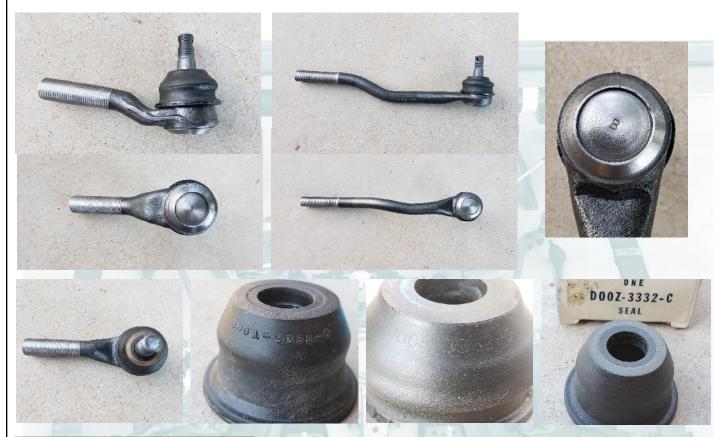
#### Tie Rods 1971 –1973

Tie rods from 1971 to 1973 are almost exactly the same as the 1970 design, except the inner tie rod design is now changed. The tie rods still have the larger style tie rod ball stud that had a 1/2-20 threaded end. The inner tie rods are a D1ZZ-3A131-A and the outer tie rods are a D00Z-3A130-B. The tie rod boot has an engineering number of D00A-3332-C molded in the boot and come in both a large and small print with the difference being two different vendors supplying the boots.

The tie rod adjusting sleeve is a C2AA-3310-B with an 11/16-18 thread. The clamps are a B7A-3287-A. Bolts have a 5/16-20 coarse thread design. There were three suppliers of the bolts; Ajax Bolt and Screw Co (A), Cold Heading Company (CH), and Republic Steel Corporation (RSC). The bolts are held in place with a locking style nut as shown in the photos with two versions of locking nuts being used from two different sources.
