# 1969-1970 Mustang Horns (and the oil cooler option)

M A R C U S A N G H E L

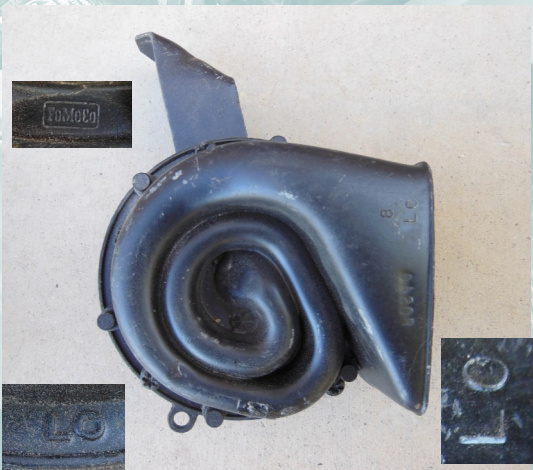
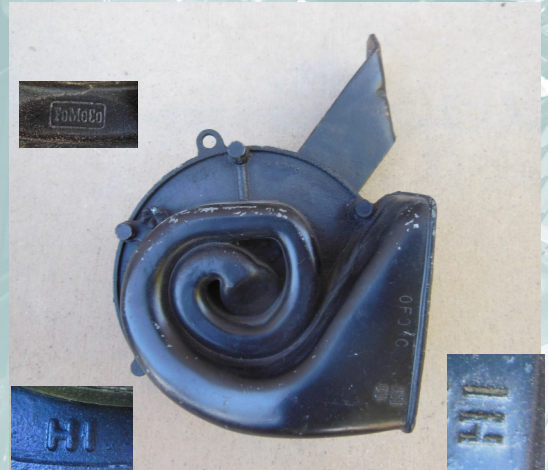
**Low Pitch horn:** Identified by the LO stamping on the side of the die cast housing and the edge of the bellmouth. Also has a single FoMoCo stamp on the edge of the housing. These horns have a longer coiled tube length to create a lower horn pitch.

**High Pitch horn:** Identified by the HI stamping on the side of the die cast housing and the edge of the bellmouth. Also has a single FoMoCo stamp on the edge of the housing. These horns have a shorter coiled tube length to create a higher horn pitch.

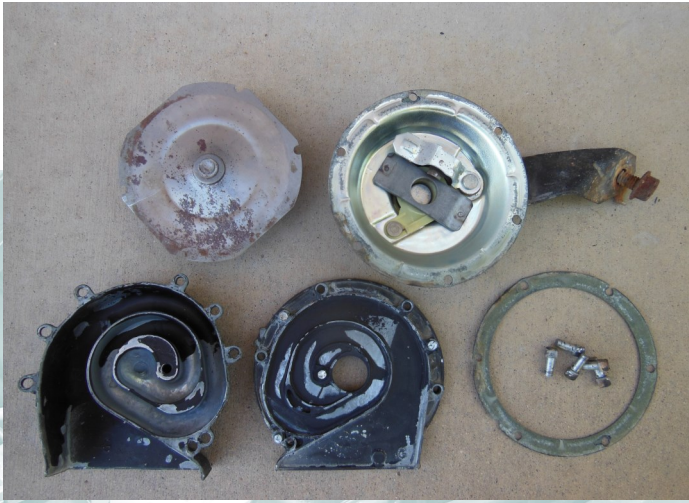
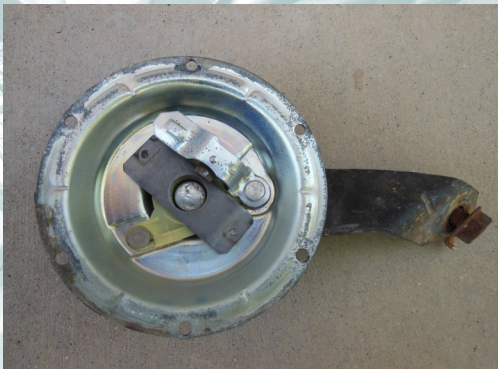
Pictures here show what a horn looks like that is completely opened up. The pieces consist of three diecast sections, a steel diaphragm, electromagnet, contact points, gaskets, and rivets. When voltage is applied the electromagnet is activated which oscillates the diaphragm. This opens the contact points which de-energizes the electromagnet and relaxing the diaphragm. This happens hundreds of times a second which then blasts thru the megaphone housing creating the sound we hear.

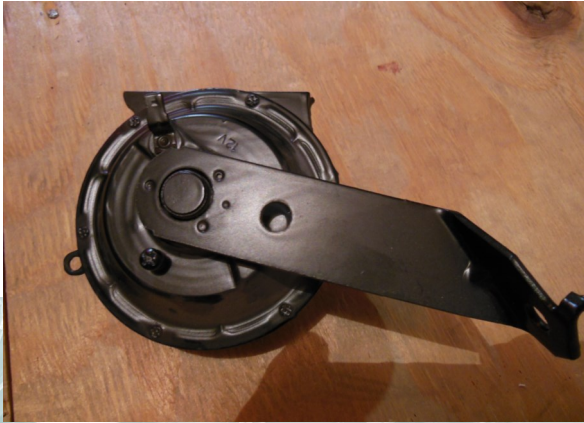
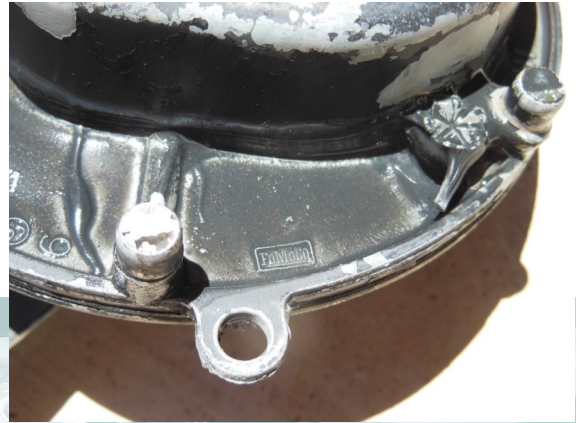
**Paint:** All horns were originally dipped in paint (not sprayed) and although not easy to spot can be seen in some of the runs that originals have.

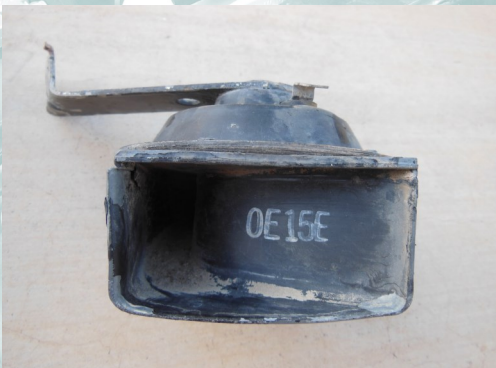
May 15, 1970

**Date Codes:** All horns during this time period have date codes that were either stamped into the housing near the edge of the bellmouth or on rare occasions were ink stamped just inside the bellmouth.

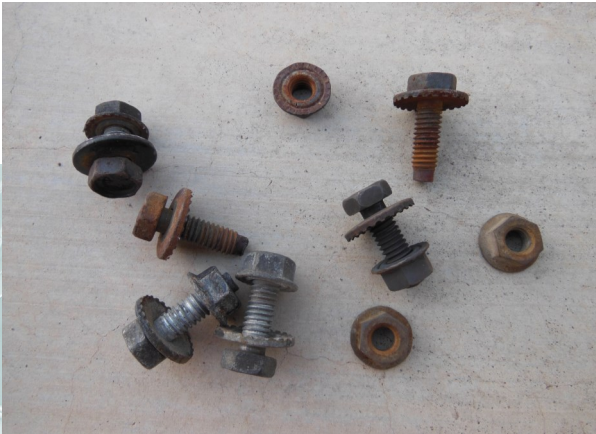
**Mounting hardware:** For standard horn installation (no oil cooler) the assembly manuals for 1969 and 1970 both show the bolt being installed from the back of the radiator support and the lock nut installed from the front. Although this is what is shown, this was not always what was done on the assembly line. It could have been installed either way. Notice that the bolts have serrated washers to help cut into the metal for better grounding of the horns.

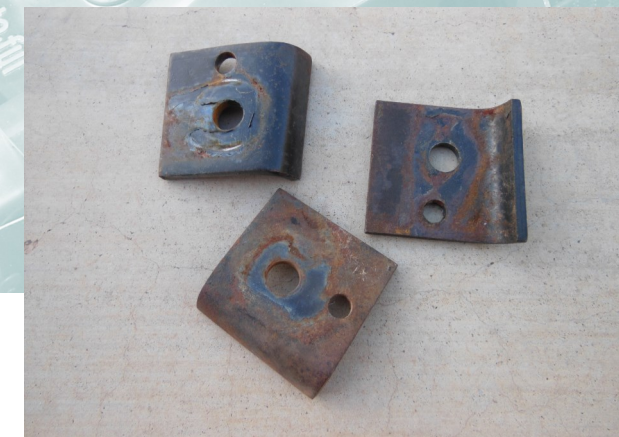
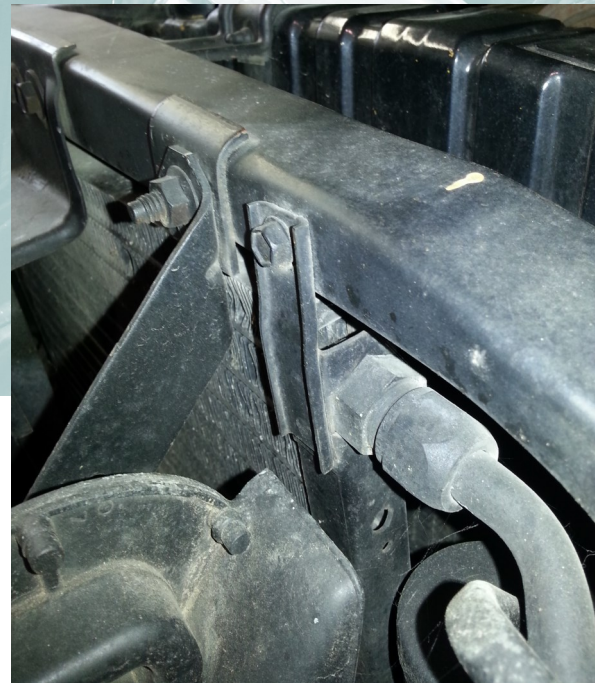
**Horn Spacer:** Only used on cars with air conditioning this spacer would be used on the drivers side for clearance issues with the condenser.

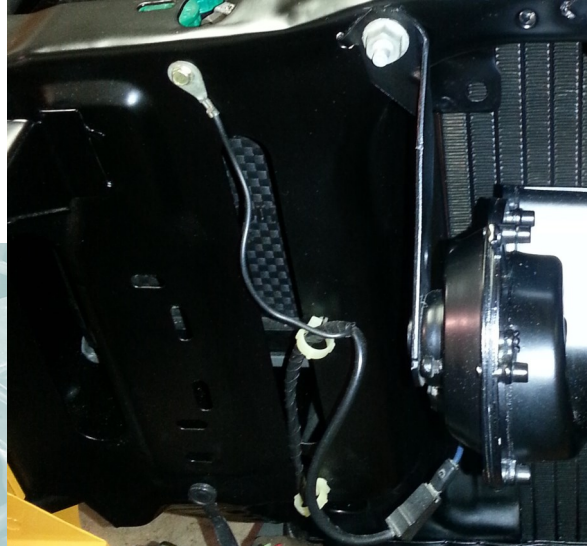
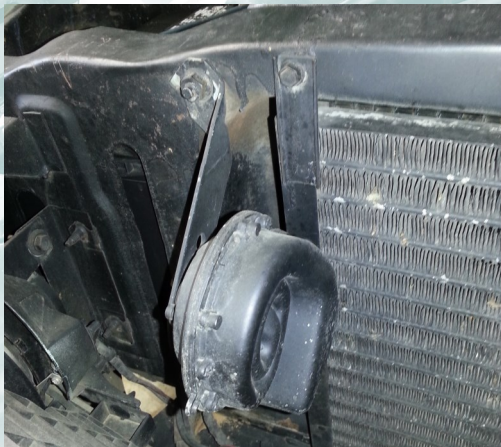
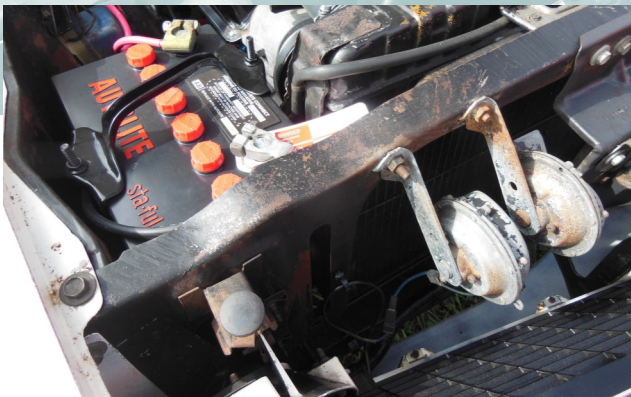
**Grounding and Paint:** At some point in 1970 production Ford added an extra grounding point to the wire harness in the horn area. Additional pictures below also show some original paint cars where the radiator support area was lightly painted and then black paint brushed on after the horns were installed. This would help with grounding issues related to the horns.

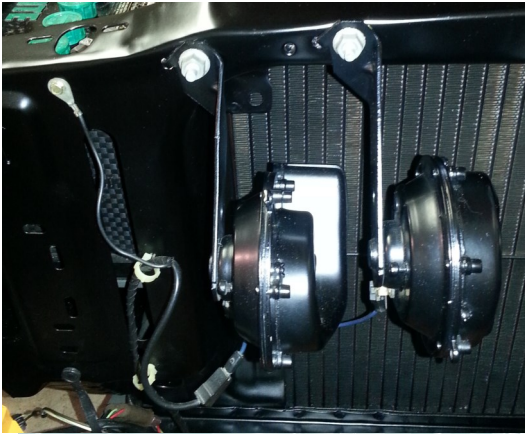
**Oil Cooler Option:** The radiator support would be modified at the factory to allow the horn to be re-located on these cars to make room for the oil cooler (if so equipped). Available on certain Mustang, Cougar, and Shelby models with a 428, and during 1970 the Boss 302 that were equipped with the oil cooler, all 1969 Boss 302's and all Boss 429's.

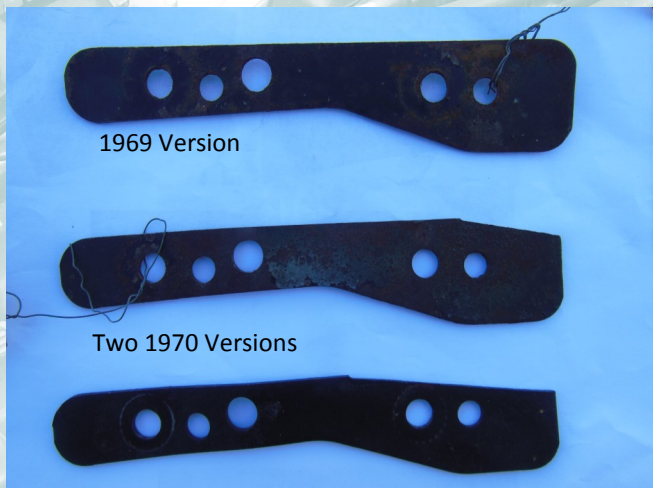
From Ed Meyers Collection

**Horn Reinforcement Bracket:** This bracket should have been placed behind the radiator support to strengthen the area where the horns were being mounted, however not every car had them installed from the factory. Three different styles are shown below starting with the first generation bracket used in 1969. Then with changes in the radiator support and possible inference with the hood locks the bracket was modified in 1970 by cutting the edge. Ford assembly manuals confirm this change.

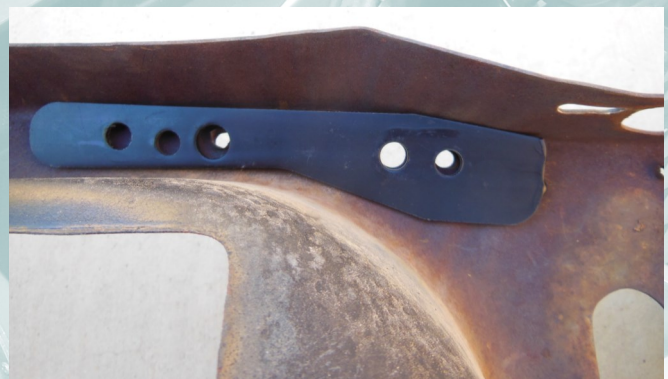
1970 radiator support to show clearance issues.

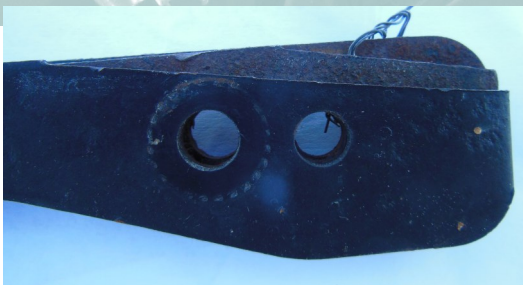
The three different versions shown side by side

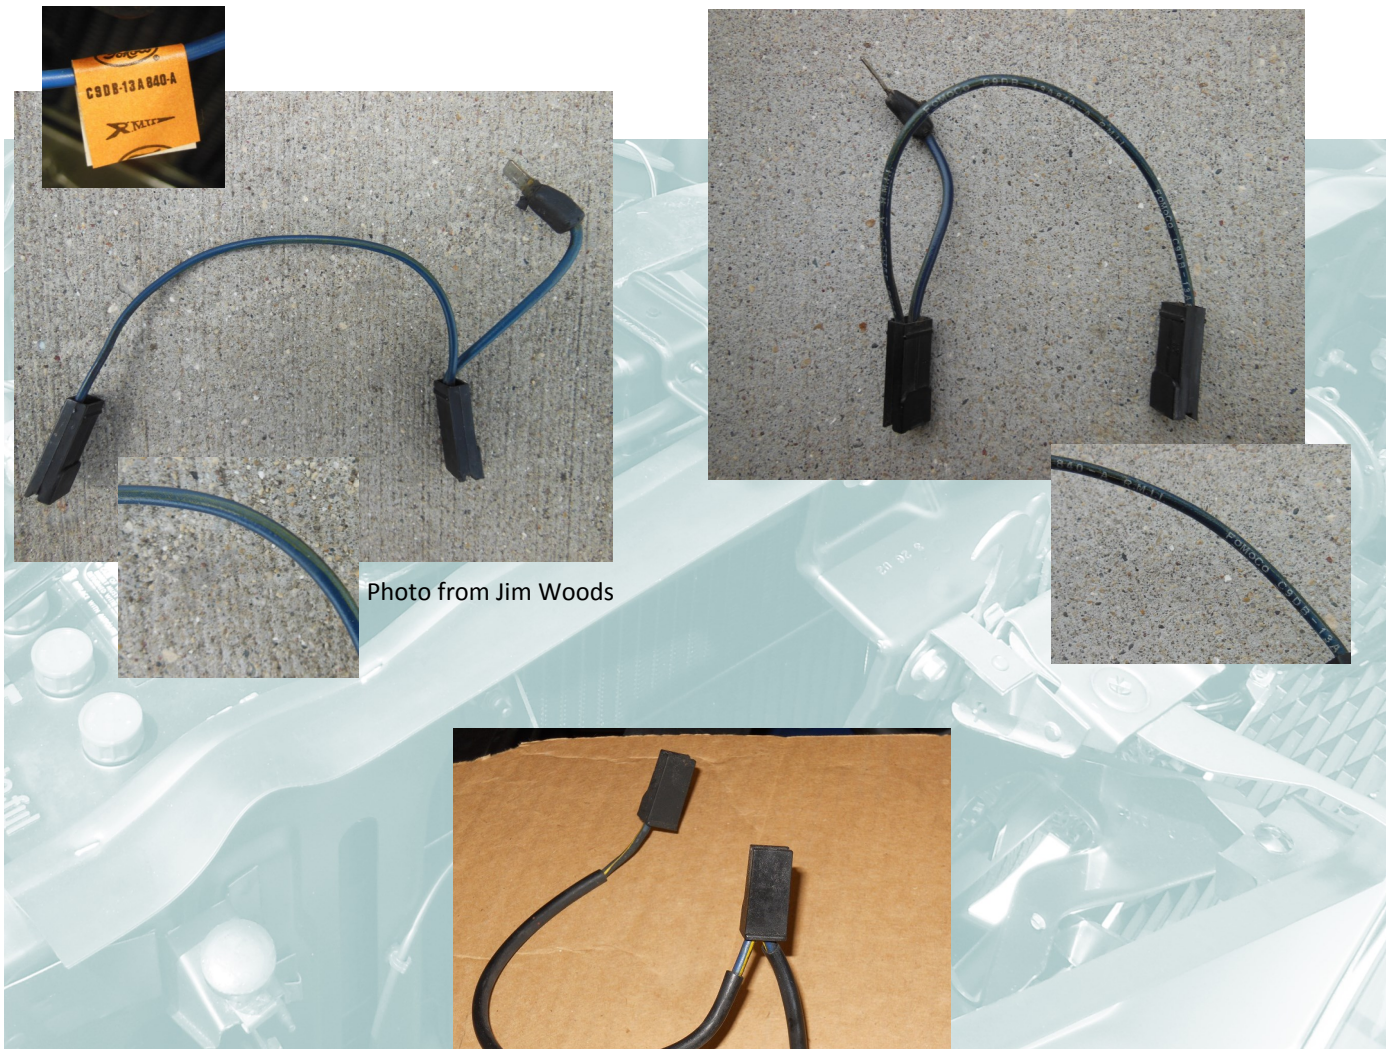
Photo from Jim Woods

**Horn Jumper Wire:** A special jumper wire was used to connect the two horns together from the same contact point of the main wiring harness. Two basic versions of this wire existed in which one was blue with a yellow stripe and the second was blue with the engineering number printed on the wire as C9DB-13A840-A. It is believed that a paper tag was only applied to the wire without the printing to identify it since the printed version already had the engineering number.

Third possible version (yet to be confirmed) that is the yellow stripe wire with a sheathing added on the wire (Courtesy of Brian Conway).

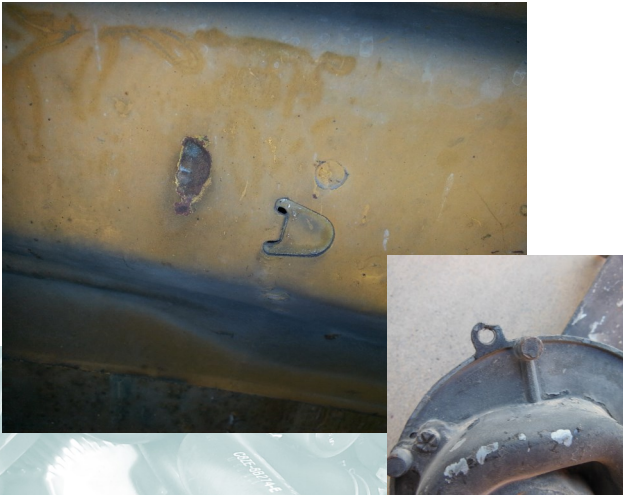
**Mounting with oil cooler 69 vs 70:** The mounting location of the horns was changed from 1969 to 1970 because of clearance issues. When moving the Hi pitch horn to the passenger side there is a tab that could rub against the hood as shown here causing damage to the hood and the horn. On some horns you can actually see this tab bent or worn down.
