1969 and 1970 Mustang, Boss, Shelby Doors

MARCUS ANGHEL

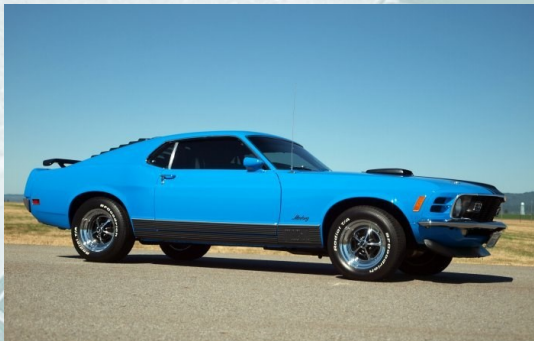
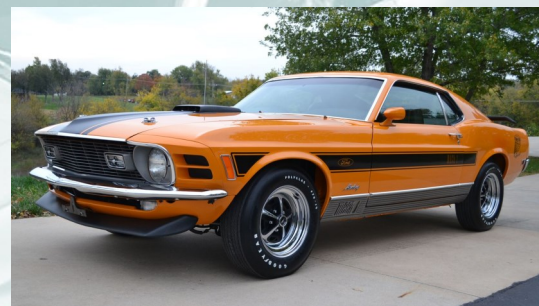
Why the difference? So why did Ford create new tooling to manufacture a different design for 1970? It was all created because of the Mach 1 design in 1970 that had a lower door moulding that went across the bottom. In order to accommodate and secure this moulding to the car, Ford needed to create a recessed area on the inside of the door where they can be securely fastened. This is the area pointed out on the next page.

A question that comes up quite a bit on restorations today is from people trying to match original 1969 or 1970 doors to a car. Although on the outside there is absolutely no difference, Ford did actually make two different style doors for these two years with two distinct different part numbers. The 1969 doors are C9ZZ-6520124-A and C9ZZ-6520125-A (for the left and right side doors), while the 1970 doors are D0ZZ-6520124-A and D0ZZ-6520125-A. And there is no difference for a fastback, coupe or convertible as they all used the same exact doors each year. The difference is on the inside plus some minor other differences we will point out here. With this guide it should be easy to spot and look at doors when looking at a car, or buying parts. It should be noted, that some very late production 1969 Mustangs could already have had 1970 doors installed from the factory.

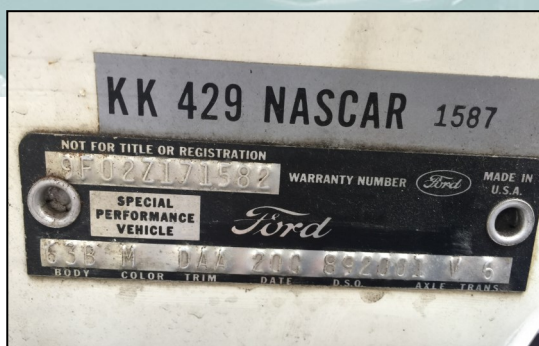
Unrestored 1969 Boss429, showing warranty plate with added original KK sticker.

Other main difference. The other main difference between the two years is the way the warranty plate (or sticker) is attached on a 1969 drivers side door vs a 1970 drivers side door. In 1969 you can see here that it is a plate attached with two rivets on the lower door jamb. In 1970 this was changed to a sticker. Note that in the 1970 model year this decal changed color as it was originally made by Ford in white and then changed to blue around March of 1970.

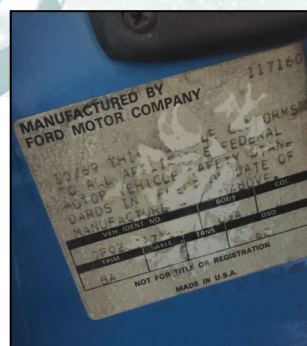
White decal used till March 1970

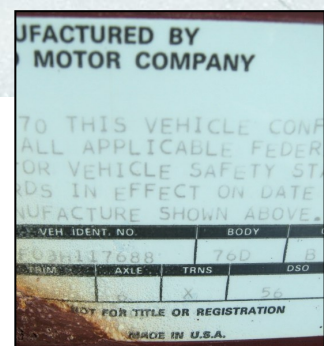
Blue decal used starting March 1970

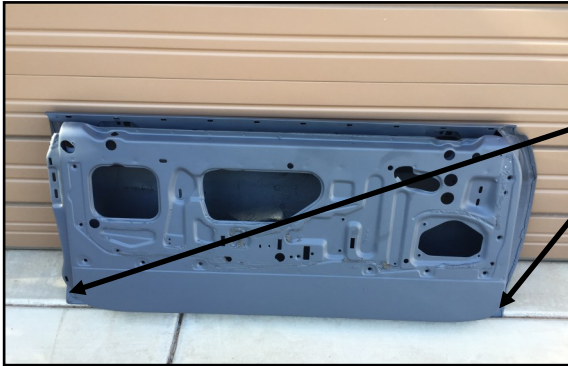
1969 Doors

Shown here for reference the areas on the inside of the door that differ between 1969 and 1970. This would be the two inside corners of the door –on both the front and rear edge of the door.

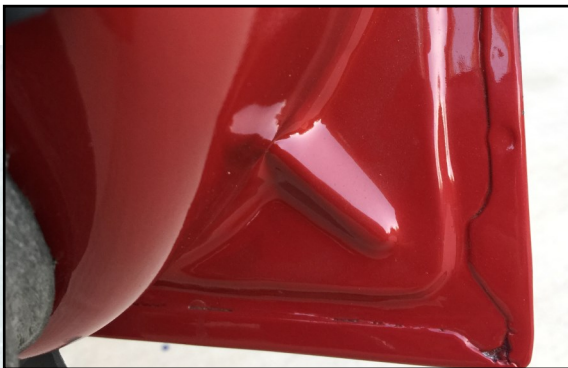
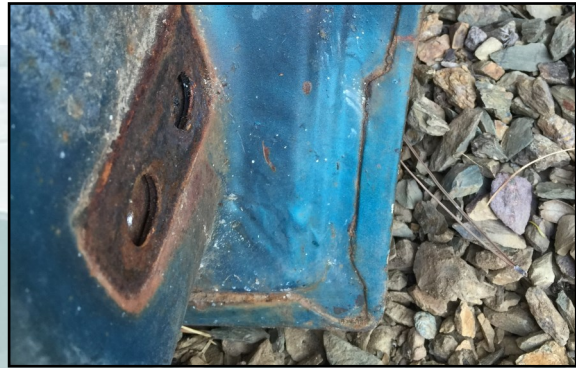
Pictures below show the close up of these areas. Original 1969 doors are the hardest to find as the 1970 design was eventually used for service replacements since it can fit for all applications between the two years.

Note: All 1969 and 1970 Shelby's only use the 1969 style doors for both years.

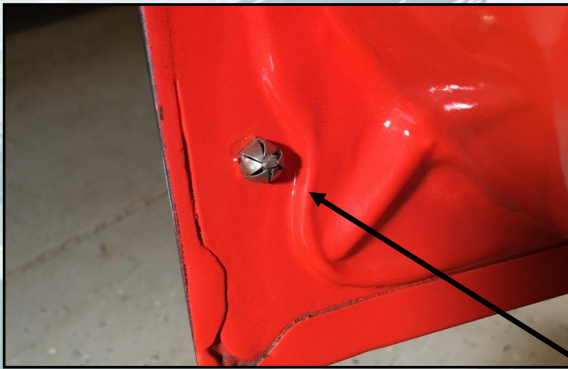
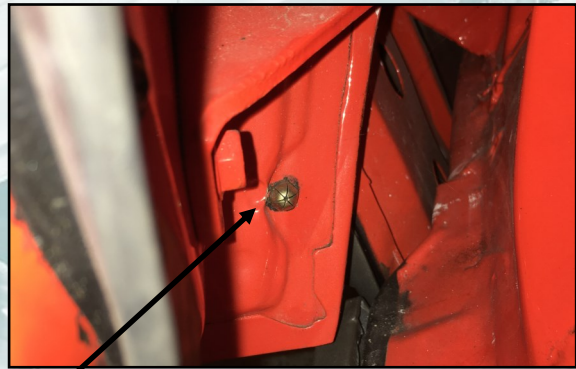
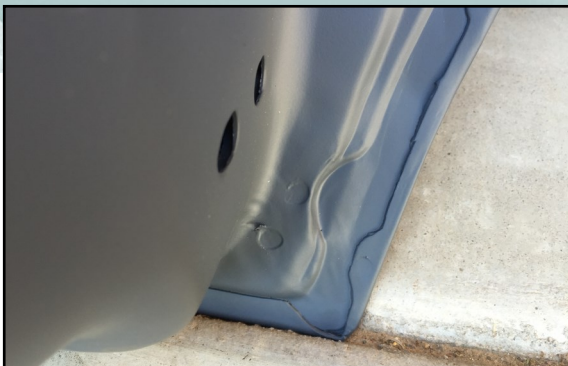
1970 Doors

Shown here the added recessed areas that don't exist on the 1969 doors with the installed mounting hardware for the Mach 1 trim.
