1969 and 1970 Fastback Interior Quarter Trim Panels

All 1969 and 1970 fastbacks used the same style interior quarter trim panel piece regardless if they had a fold down seat or a non fold down seat. However, even though the 1969 and 1970 used the same part numbers, they are actually different panels that can easily be identified when installed. Details and pictures here to show what is correct on your car.

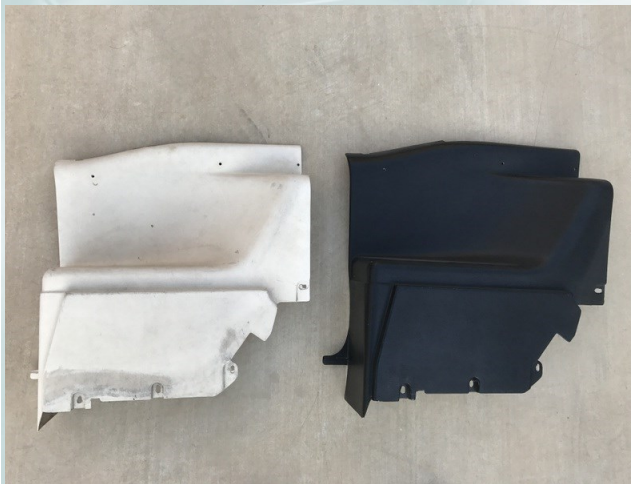
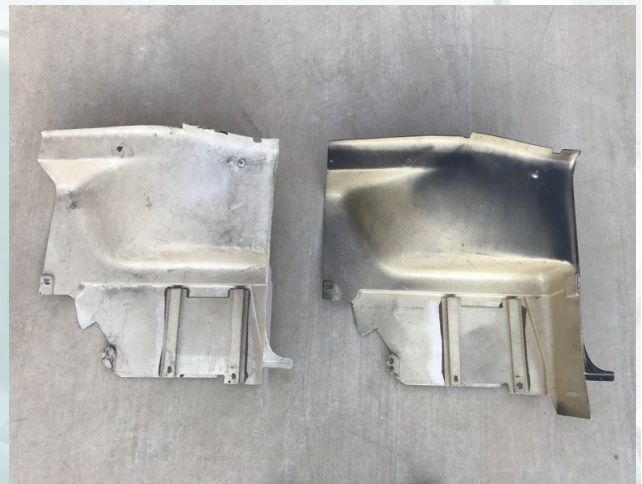
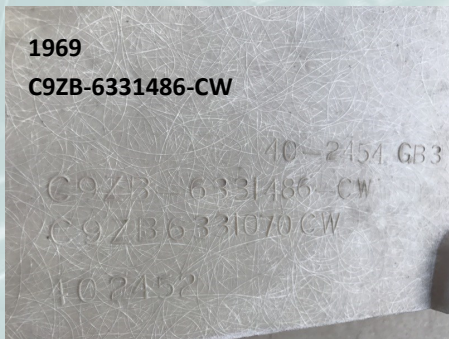
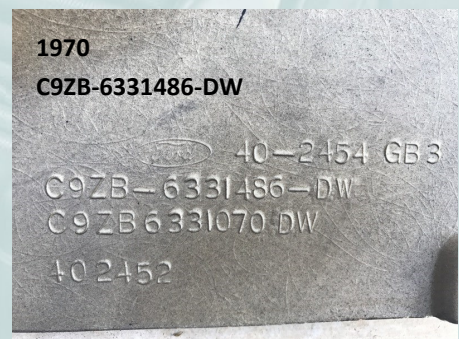
The actual part number for the right side panel was a C9ZZ-6331486-A and for the left side panel was a C9ZZ-6331487-A. These panels originally came in about 10 different interior colors that Ford offered for the Mustangs.

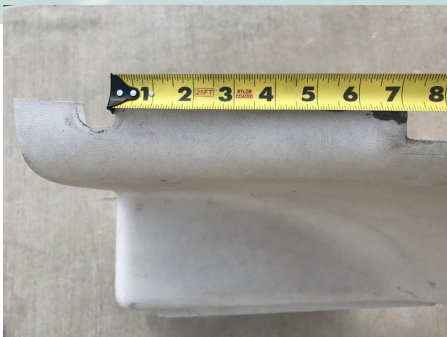
1
9
6
9

The engineering numbers changed in 1969 from a C9ZB-6331486-CW to a C9ZB-6331486-DW in 1970. With that change came the amount of the panel that was cut by the quarter window as shown from 7 inches to 8 inches.

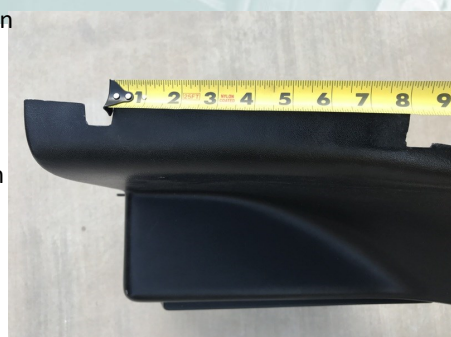
1
9
7
0

This is because in 1970 they stopped using the interior quarter window cap—shown next page.

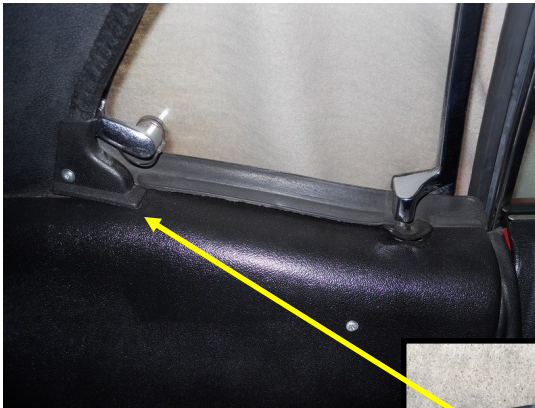
1969 Shown here with the quarter window cap to cover the cut area of the panel. This piece is not used on a 1970.

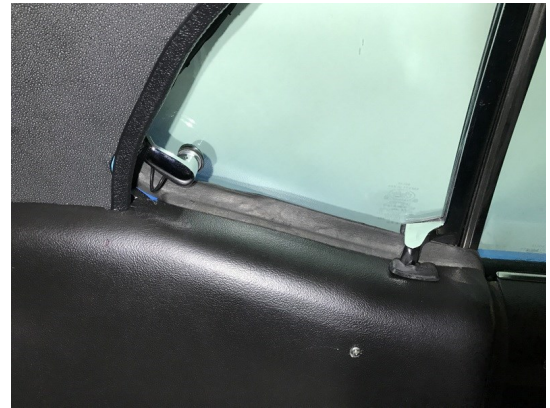
1970 The change in the cut out area no longer requires the quarter window cap anymore. This 1 inch difference eliminates the need for this added piece.

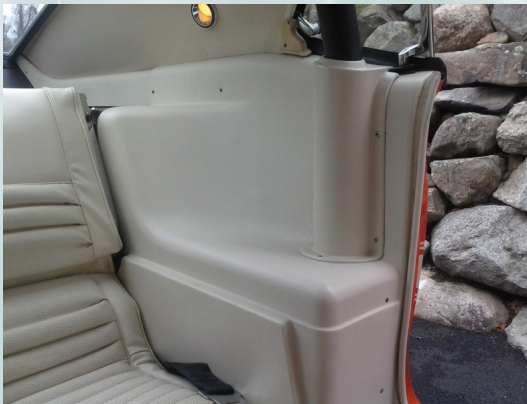
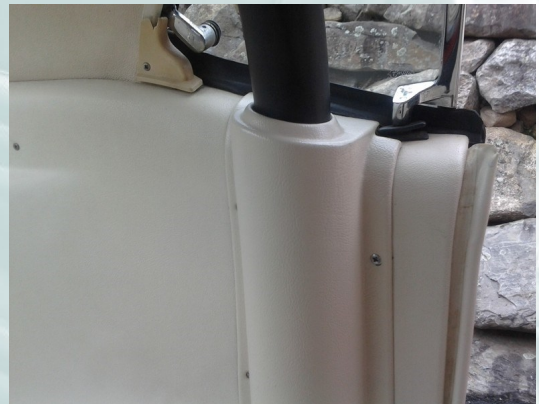
The 1969 and 1970 Shelby interiors came in only black and white so these panels only come in two colors. Because of the cut out area for the roll bar you see these pieces being different than a normal fastback piece. All Shelybs should have the quarter window cap.

The exception to this is the 1969 and 1970 Shelby's. The part numbers for these panels were a C9ZZ-6331486-A1W for the left side and a C9ZZ-6331487-A1W for the right side. Same panels for both years because all Shelby's were really built in 1969. These panels were cut for the roll bar and were serviced in only two different colors—black and white.

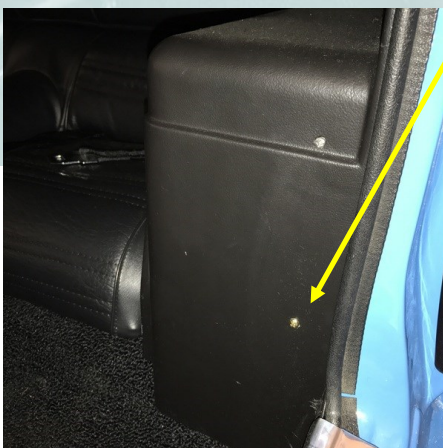
Gold? It is not uncommon to see on original cars the lower panel screw being different and actually being a zinc dichromate finish. This would be instead of the silver finish we see on the other screws for this panel.
